VEHICLE CRASH TESTS OF A CONCRETE
MEDIAN BARRIER RETROFFITTED WITH
A CONCRETE GLARE SCREEN

Final Report # FHWA/CA/TL-92/05

Caltrans Study # F87TL32

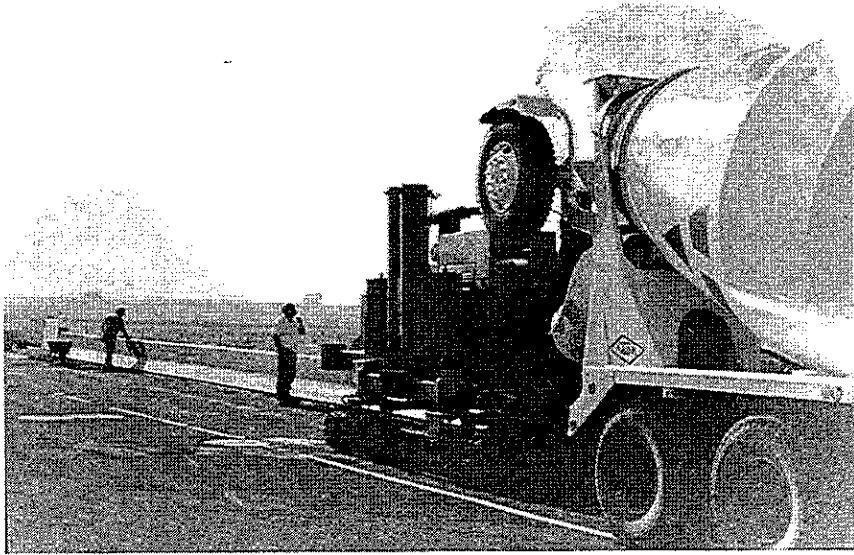
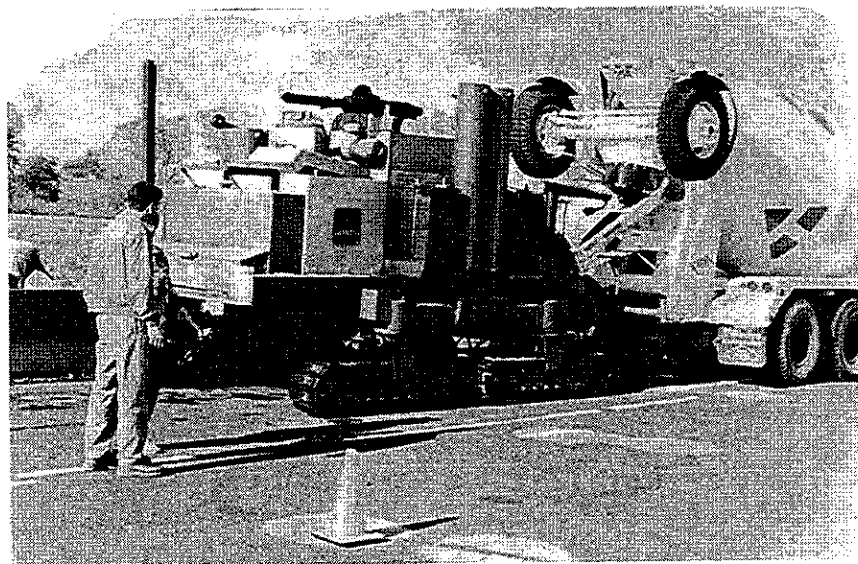
Figure 4: CGS Under Construction

Initially, there were some problems with the slipforming operation. The new mule for the CGS had never been used before. The first few feet of the CGS that were slipformed pulled apart, contained rock pockets, and seemed unstable and easily warped away from plumb. This was due to inadequate vibration during the slipform operation and also due to the low slump concrete. To counteract this, a bit of water was added to the concrete and the location of the vibrators was changed.

Considerable patching and finishing were required after the CGS was slipformed, particularly in the beginning section. Once the finishing was complete, the CGS generally appeared straight, plumb and consolidated. It is expected that the ease of slipforming and the integrity of the CGS would improve as the contractor gained experience with the new mule. Figure 4 shows the glare screen under construction, and Figure 5 shows it after hand finishing. Static strength results from concrete test specimens of the CMB and the CGS are tallied in Appendix E.

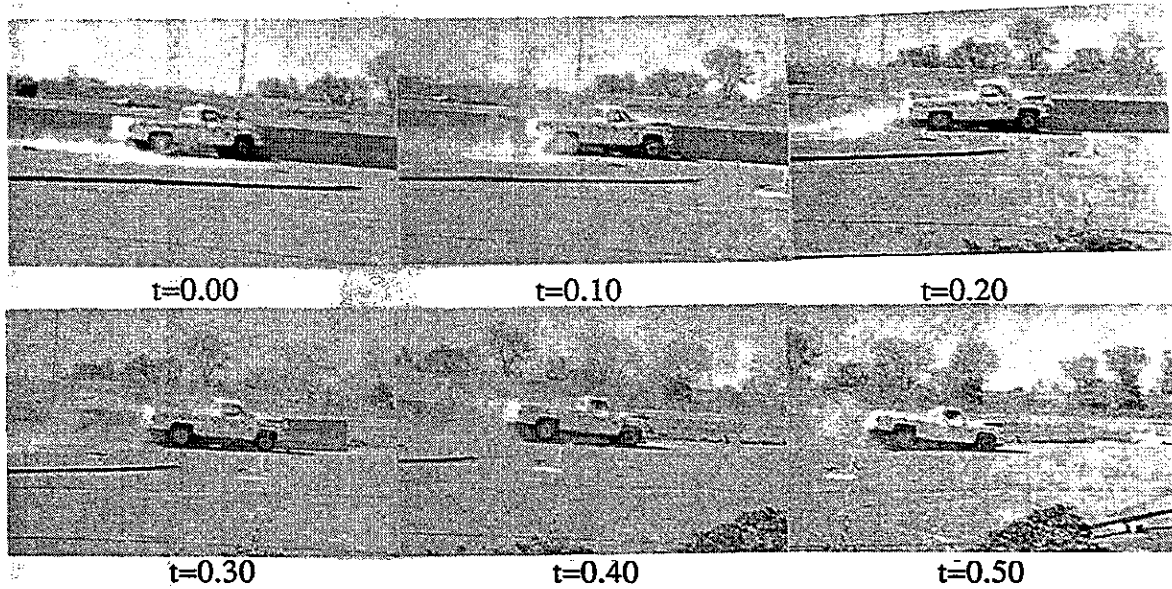
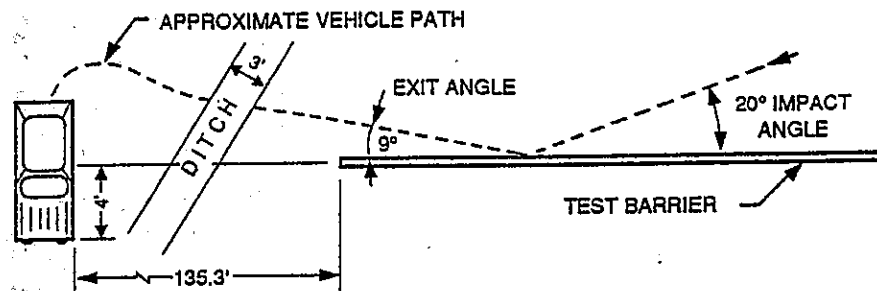
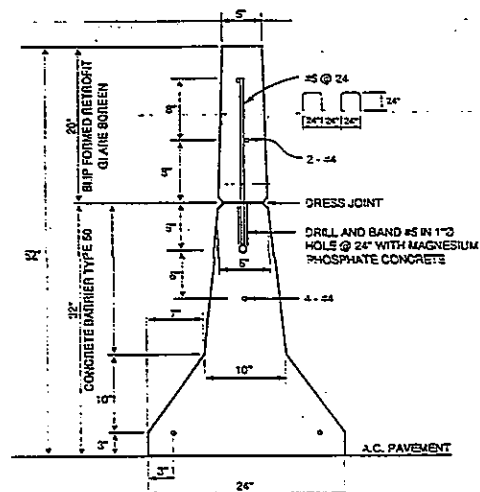
Figure 6: Data Summary Sheet for Test 481

Test Data:
Occupant Impact Velocity: 9.9 fps long. / 20.6 fps lat.
Ridedown Acceleration: 1.4 g's long. / -20.7 g's lat.
Max. 50 ms Avg. Accel.: -4.6 g's long. / -11.3 g's lat.
TAD/VDI: 11LFMW5/LFQ-4
Max. Roll, Pitch & Yaw: 13.1°/-9.4°/0°
Barrier Displacement: 0 inch
Max. Dynamic Deflection: 0.39 inch
Barrier Damage: Few scrapes and tire marks

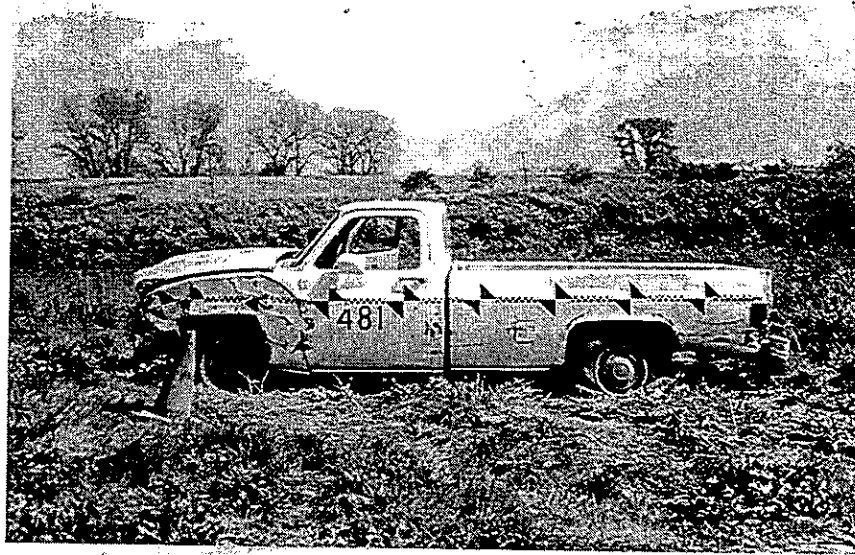
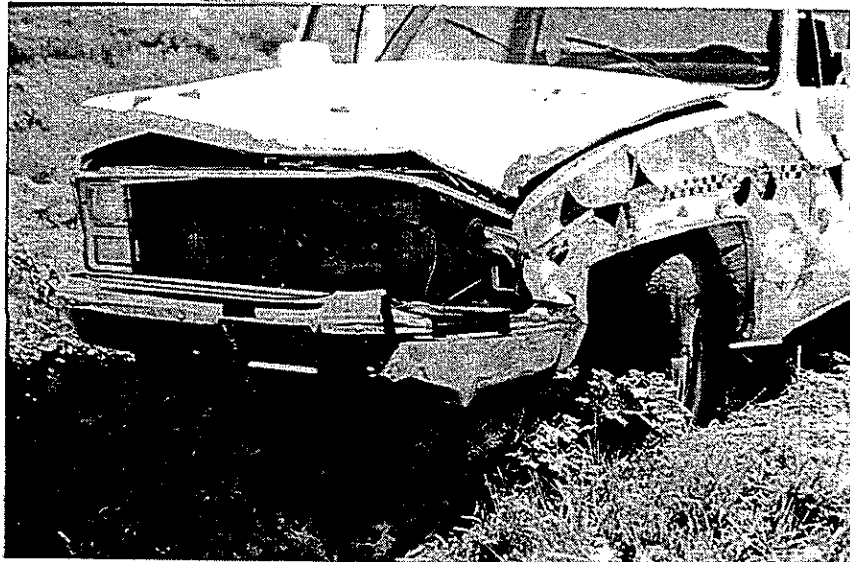
Figure 8: Post-Impact Photos, Test 481

The test vehicle was severely damaged with crushing of left side body sheet metal. The contact pattern was initiated at the left corner of the front bumper which was crushed and bent during the impact. The grill frame was crushed at its left side and dented at its right. The grill fell out of the grill frame. The radiator was pushed back to the fan. The hood was closed and could not be opened. The left door was scraped, jammed and could not be opened. The left mirror was broken and its frame was bent inward. The left side of the pickup truck bed was severely scraped and crinkled. The truck bed was twisted causing two inch differences between the cab and the bed on the truck's left side. On the right hand side of the vehicle, the front fender was crinkled, the brake light was pushed up and broken, and the right door was jammed. All tires were flat and torn except the right front tire. The rim of the left front wheel was bent and the tire came off of the right rear wheel due to snagging on the guidance bracket. There was no intrusion of vehicle or barrier parts into the passenger compartment during impact.

There was no evidence of any structural distress of the CGS or CMB. A few hair like cracks were observed but were indistinguishable from cracks due to shrinkage. They may have preexisted the crash. Lateral movement of the CGS was measured during the test; dynamic deflection was up to 0.39 inches (0.01 m) at the top face, but there was no permanent deflection.

The only damage to the barrier was a few scrapes and tire marks. The length of gouge marks on the CGS was 11 ft (3.3 m) and about 12 ft (3.6 m) on the CMB.

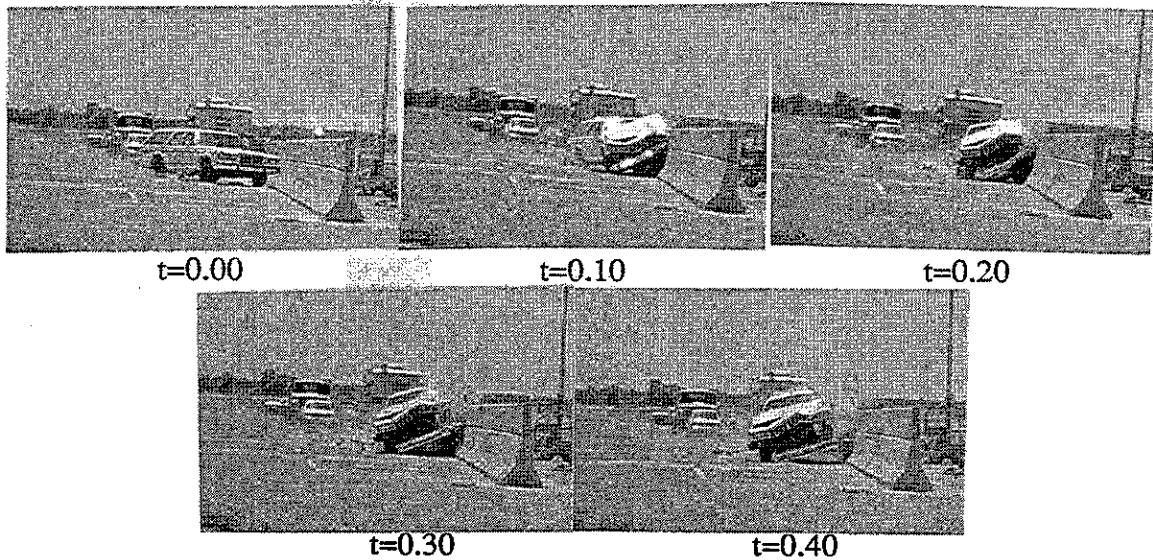
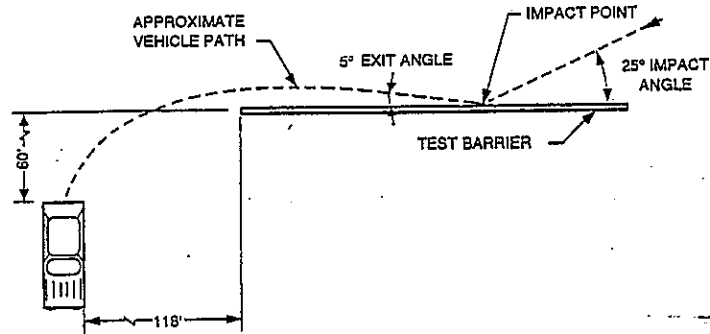
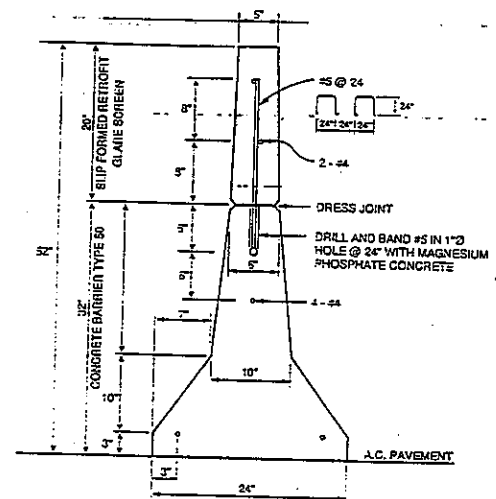
Figure 9: Data Summary Sheet for Test 482

Occupant Impact Velocity: 21.2 fps long. / 21.9 fps lat.
Ridedown Acceleration: -5.5 g's long. / -16.3 g's lat.
Max. 50 ms Avg. Accel.: -6.6 g's long. / -10 g's lat.
TAD/VDI: 11LFMW5/LFQ-5
Max. Roll, Pitch & Yaw: 18°/5°/0°
Barrier Displacement: 0 inch
Max. Dynamic Deflection: 0.21 inch
Barrier Damage: Few hair-like cracks, scrapes and tire marks.

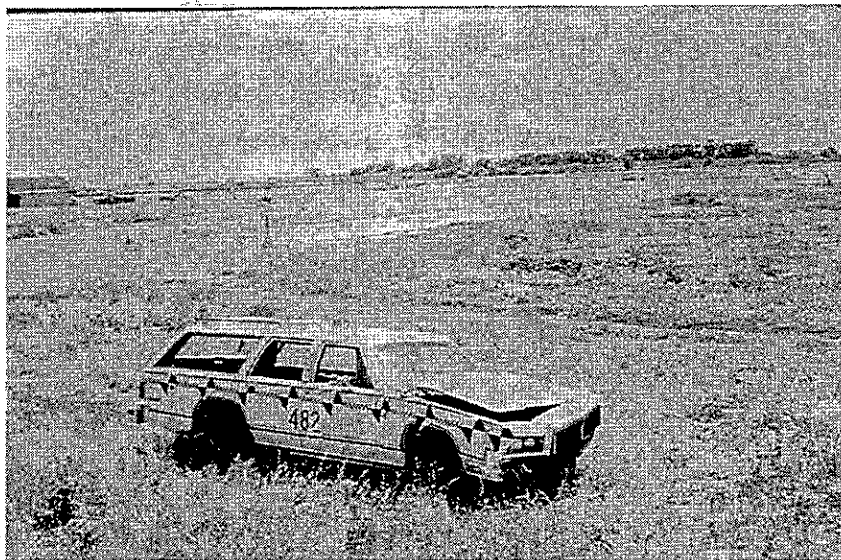
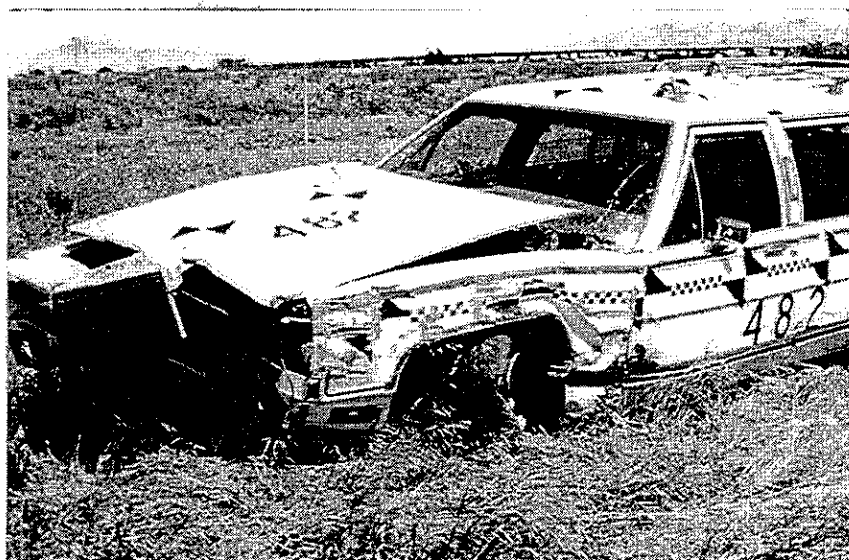
Figure 11: Post-Impact Photos, Test 482

The test vehicle was severely damaged. The sheet metal on the left side of the body was crushed and the front bumper was disconnected from the car. The contact pattern initiated at the left corner of the front bumper resulted in the left shock bolts (bolts attaching shock absorber to body) being completely sheared off during the impact. Consequently, the entire bumper was torn off and thrown 21 feet (6.4 m) away from the barrier face and 35 feet (10.7 m) from the downstream end of barrier. The grill frame was crushed at its left side and cracked at its right. The radiator was pushed back to the fan. The hood was closed and could not be opened; one of the hood hinges was broken. The whole front part of the car was moved toward the right. The first target on the hood was displaced 7.5 inches (0.2 m) as compared to the car centerline. The left door was scraped, jammed and could not be opened. The left front fender was severely scraped and crinkled, and moved back about two inches (0.1 m). The left rear door was scraped; the left door post was torn almost loose at the roof. The right front fender was crinkled and broken. The right door was jammed. The roof over the door posts was crimped. The left front tire was flat and torn. All wheels had restricted movement due to front and rear axle failure.

There was no evidence of any structural distress of the CGS or CMB. The only damage imparted to the barrier was minor extension of a few preexistent hair line cracks. About eight hair like cracks one to four and a half inches long developed on the top face of the CGS over a length of 3.5 feet upstream from the 60-foot mark. A preexisting crack root on the barrier face at about 60 feet from barrier upstream end went on for an additional one and a half inches. Two preexisting contraction cracks on the back of the barrier branched out five hair like cracks three to four inches long. These preexisting cracks were located at 0.4 and 6.4 feet downstream from the 60-foot mark.
